Manhole Inspection Summary

Manhole # S11Y__001MH

Insp Date: **4/7/08 11:12 AM**

Location Address: **3300 Benson Ave**

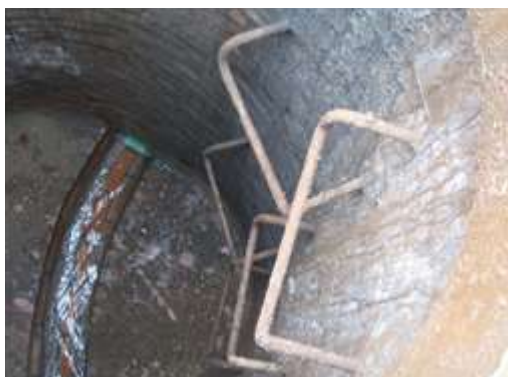
Defect 3

Infiltration at corbel and barrel

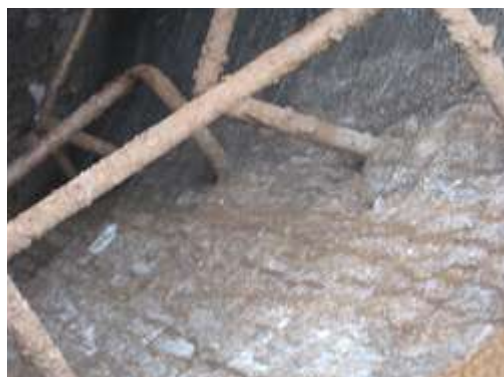
Defect 1

Steps Count: **4** Missing: **0** ☒ **Corroded**

Corroded steps

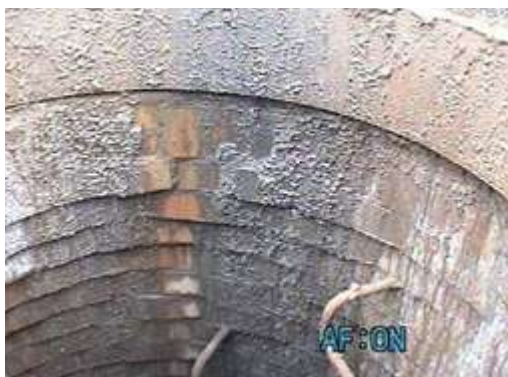
Defect 2

Frame Offset: **1** (in.) Condition: ☐ Sound ☐ Cracked ☒ **Leaks**

offset, Infiltration at frame, chimney and corbel

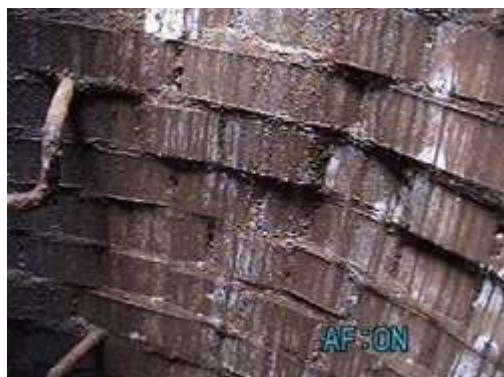
Defect 3

Infiltration: ☐ None ☐ Joint ☐ Cracks ☐ Mortar ☐ Roots ☒ **Wall**

Infiltration along barrel

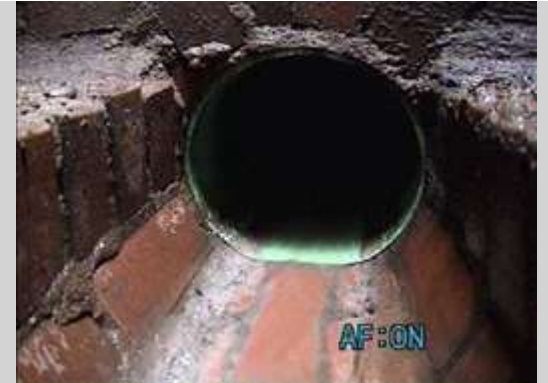
12 O'Clock Outflow

Pipe Height: **8.4** (in.) Rod and Bar (Angled)
Pipe Material: **PVC** ☐ Pipe Lined
Invert Depth: **8.49** (ft.) Flow Characteristics: **Fast**
Deposits: ☒ None ☐ Mud ☐ Sludge ☐ Debris ☐ Grease
Silt Depth: **0** (in.) Deposits Extent:
Infiltration: **None** Pipe Seal Cond: **Sound**

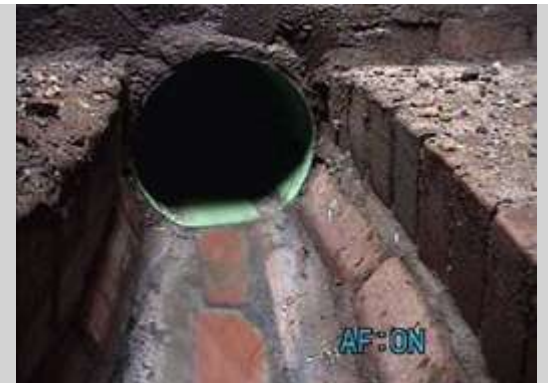
5 O'Clock Inflow

Pipe Height: **7.2** (in.) Rod and Bar (Angled)
Pipe Material: **PVC** ☐ Pipe Lined
Invert Depth: **8.48** (ft.) Flow Characteristics: **Fast**
Deposits: ☒ None ☐ Mud ☐ Sludge ☐ Debris ☐ Grease
Silt Depth: **0** (in.) Deposits Extent:
Infiltration: **None** Pipe Seal Cond: **Sound**
